2013 Big Thompson River Flood Inundation Area Loveland, Colorado

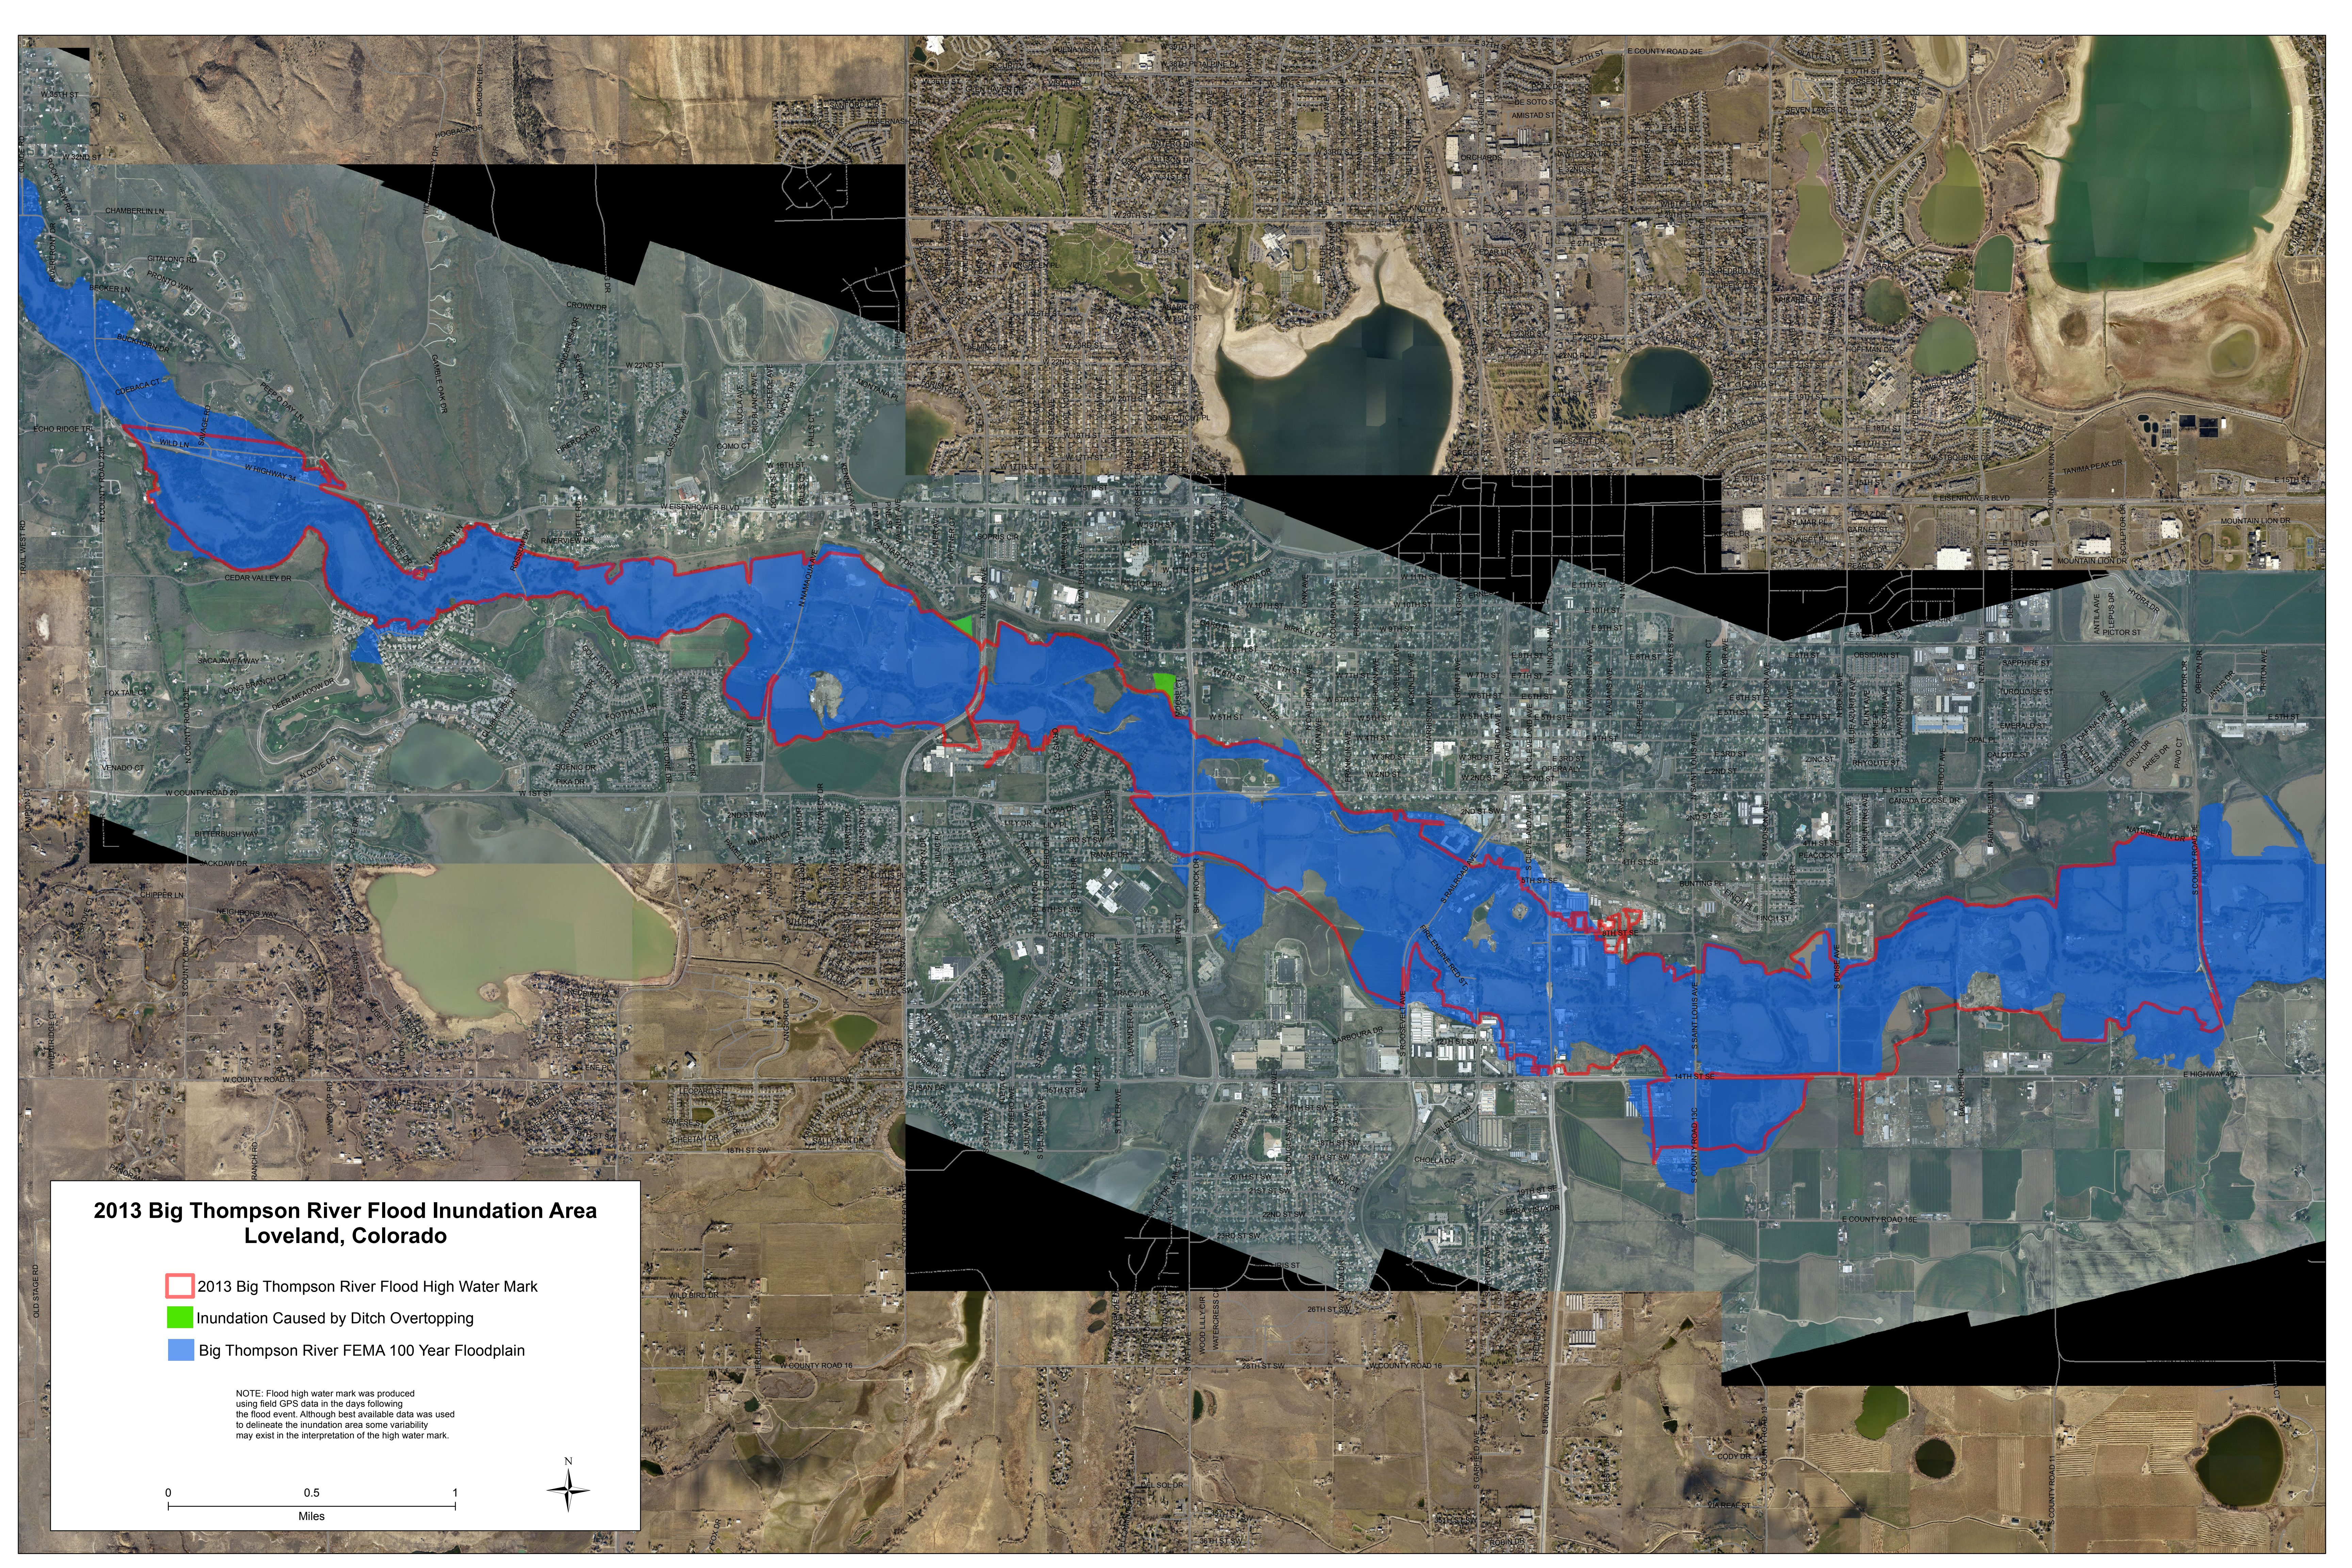
2013 Big Thompson River Flood High Water Mark
-

Inundation Caused by Ditch Overtopping
-

Big Thompson River FEMA 100 Year Floodplain

NOTE: Flood high water mark was produced using field GPS data in the days following the flood event. Although best available data was used to delineate the inundation area some variability may exist in the interpretation of the high water mark.
